**Field Evaluation and Analysis of Automated Rut Measurement Systems
Data for Texas Conditions**

Thesis

The University of Texas at Austin

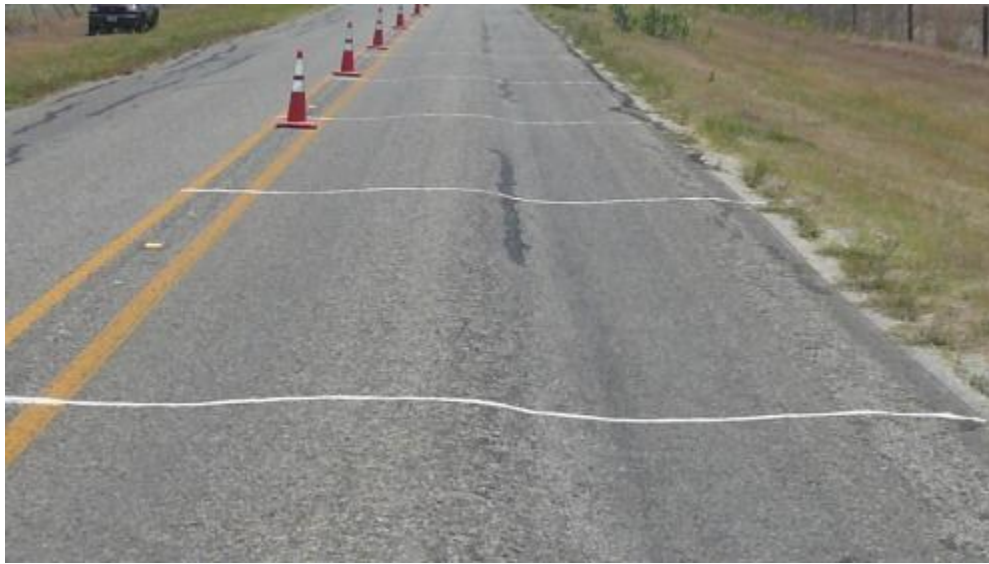
Figure 1.1: Picture of a distorted pavement section.

Figure 1.1 shows a pavement section with severe level of rutting. This picture was taken during manual rutting data collection for this study, while the lane being measured was closed to traffic. The white lines across the pavement section were marked to locate the sections at which transverse profile coordinates were measured. By observing the shape of the white lines in the picture it is possible to clearly see the rut formed at each wheel-path.

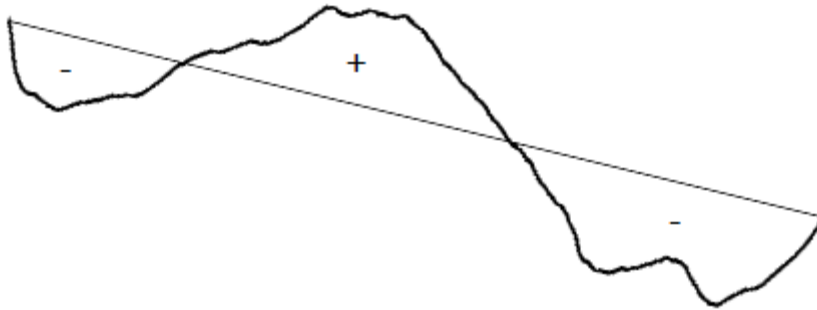
Figure 2.1: Negative and positive areas.

coordinates and the straight lines connecting the peaks of the profile. Figure 2.2 shows the Fill Area of the rutted surface in gray. All these area indices provide a two dimensional characterization of rutting. The negative and positive areas provide information about the severity of rutting, and according to Simpson, they may potentially indicate the cause of the rutting. The Fill Area index may be used as an estimate of the amount of material necessary to repair the pavement.

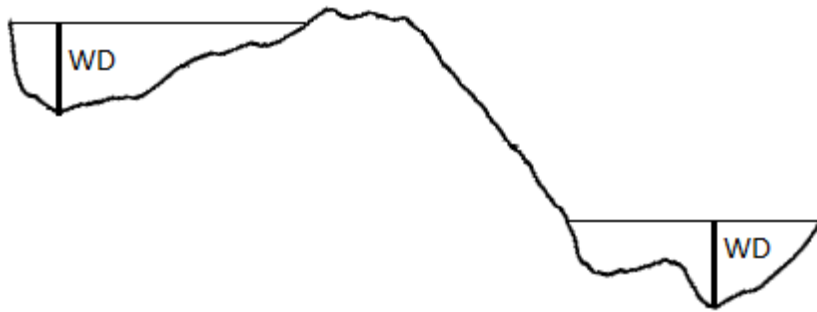
Figure 2.3: Water depth.

The water depth index is illustrated in Figure 2.3. Water may pool in the formed rut reducing the pavement drainage capacity and increasing the likelihood of wet-weather accidents due to hydroplaning. As shown in the picture, this index is obtained for each wheel-path as the maximum vertical distance (indicated in the figure as WD) between the profile coordinates and a horizontal line positioned at the maximum point at which water would pond. This index is not commonly calculated during rutting data collection. A possible reason for this may be that not all the systems currently measure the cross-slope of the pavement, which is required to calculate the index.

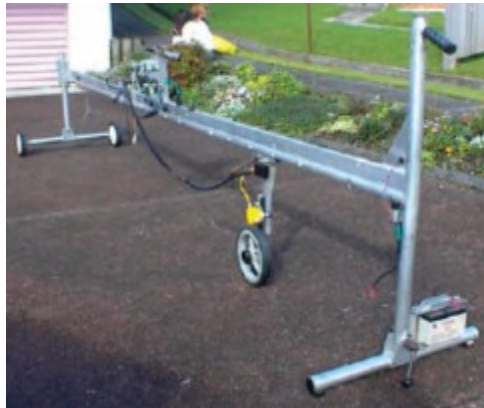
Figure 2.5: ROMDAS “TPB Reference profiler” [Bennett et al., 2002].

Several others manual profilers can also be found in the literature such as the “Transverse Profile Beam (TPB) reference profiler” (Figure 2.5) [Bennett et al., 2002] commercialized by Road Measurement Data Acquisition System (ROMDAS). These systems are generally similar in concept and usually they are capable of collecting multiple points of the profile using sensors with high accuracy and resolution, although their operation is slow and they cannot be used for network level data collection in Texas.

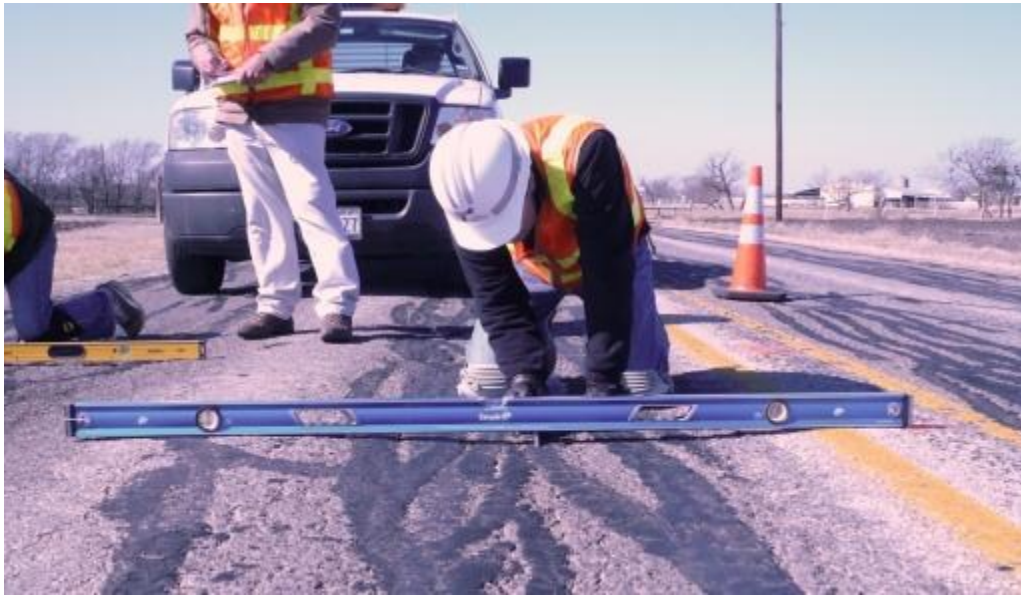
Figure 2.6: Straightedge method field measurement.

Manual straightedge rut measurement is a widely accepted standard rut measurement method. Its procedure is described by ASTM E1703, and consists of directly measuring the depth of the rut at a chosen location in a pavement surface using a straightedge and a gage (Figure 2.6).

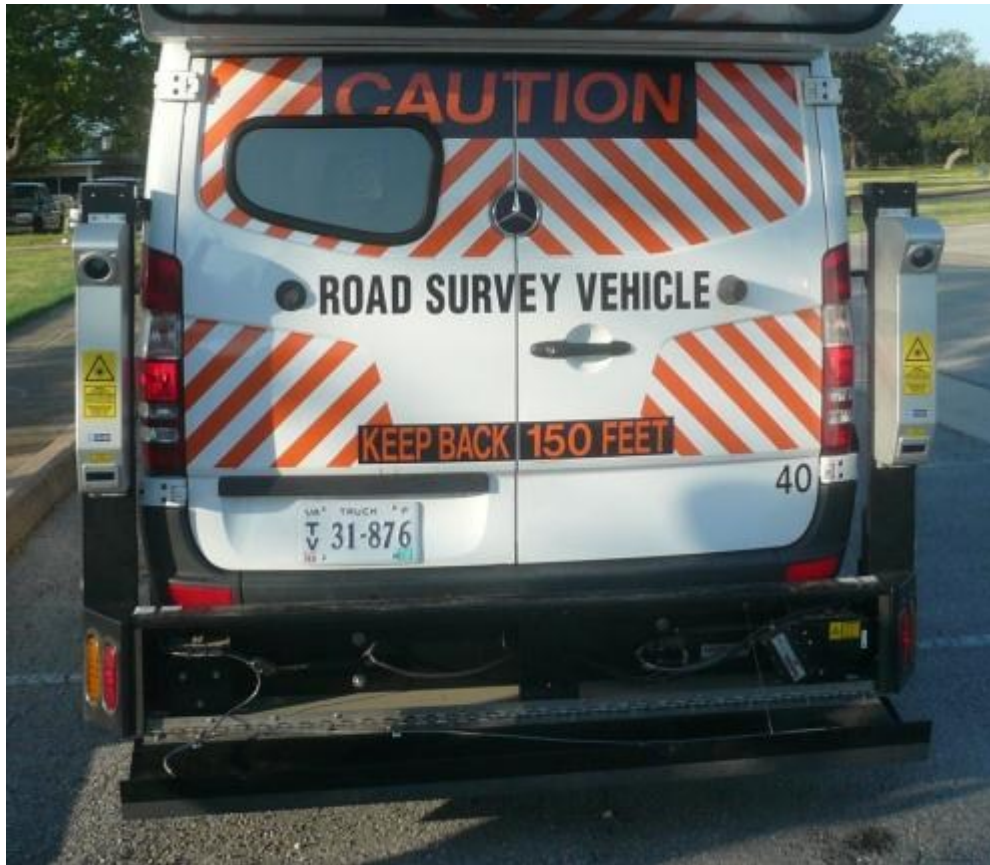
Figure 2.16: Pavemetrics INO LRMS mounted on vehicle.

INO LRMS consist of two profilometers that digitize the transverse section of the pavement with 1,280 points (Figure 2.16). These profilometers are mounted on the rear of the vehicle, and each one measures half of the width of the transverse section of the pavement.

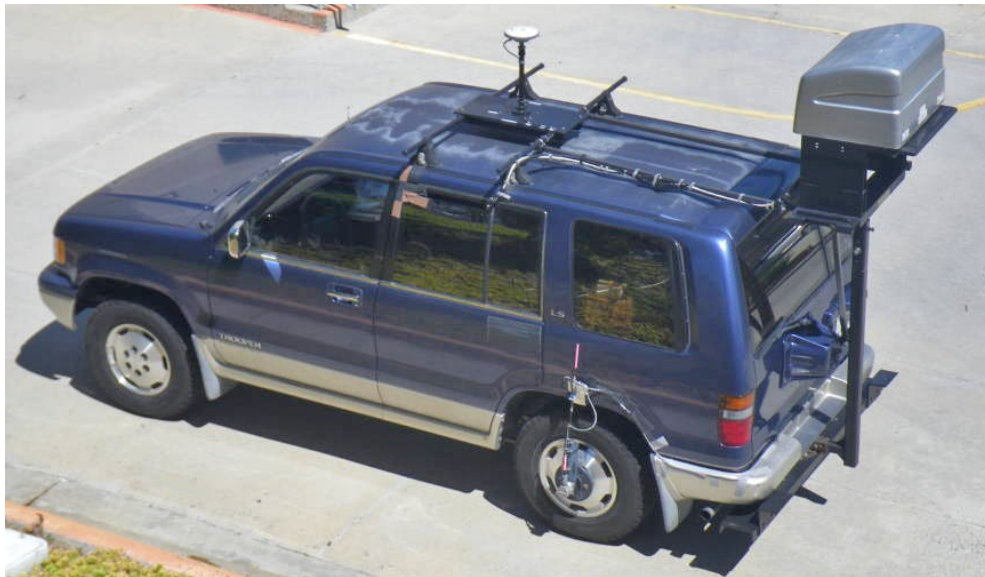
Figure 2.24: PSI PPS Scanner mounted on survey vehicle (Herr, 2009)

Phoenix Scientific Inc. (PSI) developed a proprietary system, named the Pavement Profile Scanner (PPS), for the Rolling Wheel Deflectometer (RWD). This system was and later adapted by PSI for obtaining pavement condition data such as rut and ride indexes. PSI's PPS scanner is mounted on the rear of the survey vehicle (Figure 2.24) at a height of at least half of the width that is needed to be measured. Mounted at 2.15 meters above the pavement, PPS measures a profile 4.3 meters wide in 0.75 milliseconds. The system takes 943 measurements per transverse profile spaced at a constant angle from the polygonal scan mirror, which are then converted to two-dimensional coordinates. The number and separation of points can be specified by the operator [PSI PPS White Paper, 2004].

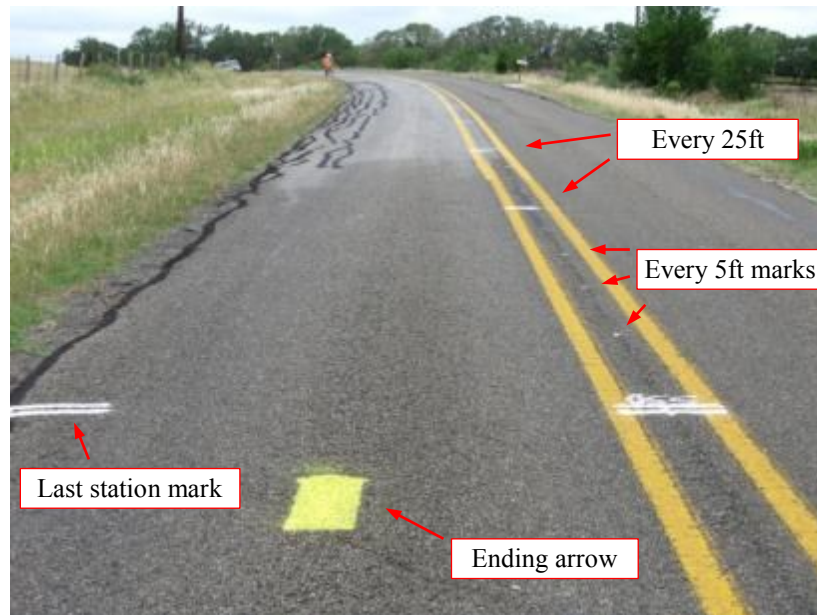
Figure 3.2: Demarcation of survey sections.

Figure 3.2 shows a picture of a section of the study which includes legends indicating the different types of demarcation used. The starting (Station 0) and ending (Station 550) stations of each section were marked painting a double stripe and leaving a 2-in wide area without paint in between to indicate the location of the station (Figure 3.3 shows a close-up picture of this type of marking). Three feet before the first station, and after the last station (travelling in the direction of traffic), a yellow or orange arrow was painted approximately in the center of the lane, big enough to be seen by the driver or data collection operator of the vehicle and indicating the proximity of the starting (or ending) station of the section. The arrow shown in Figure 3.2 is indicating the ending point of the section.

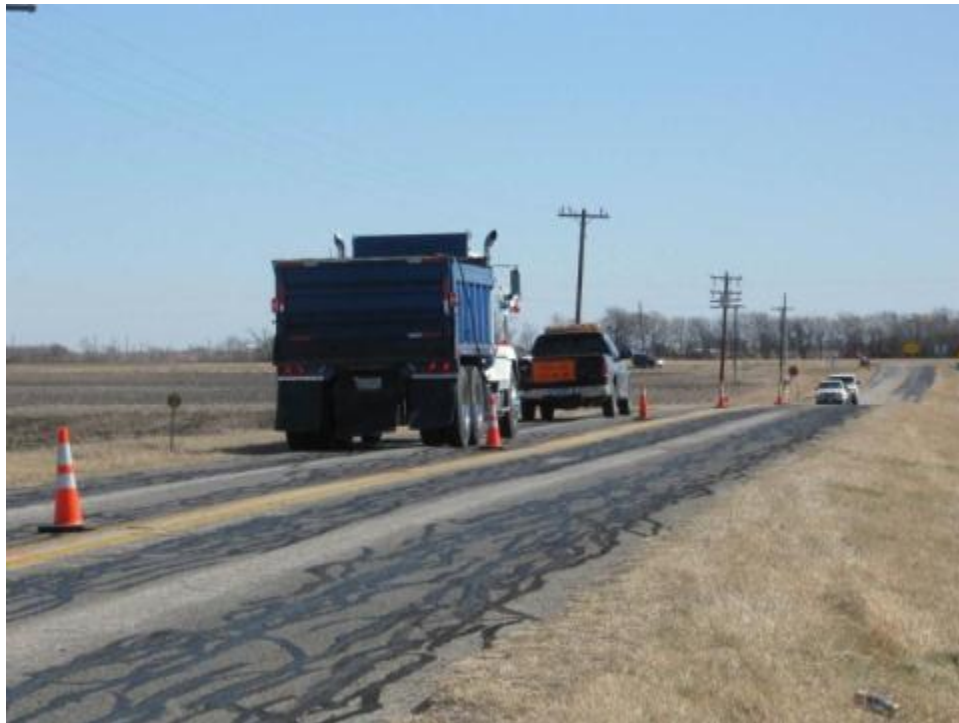
- Surface texture type: Coarse.
- Lane width: Irregular, between 9.5ft to 11.0ft.
- Shoulder: No paved shoulder.
- Horizontal curve: Straight path.
- Vertical curve: Flat.
- Observed pavement distresses: Extensive sealed and unsealed cracks.
- Additional comments: This section was resurfaced between the reference data collection and the automated measurements. Therefore, it was discarded for the comparison.

Figure 3.5: Section 1: FM 1660-1.

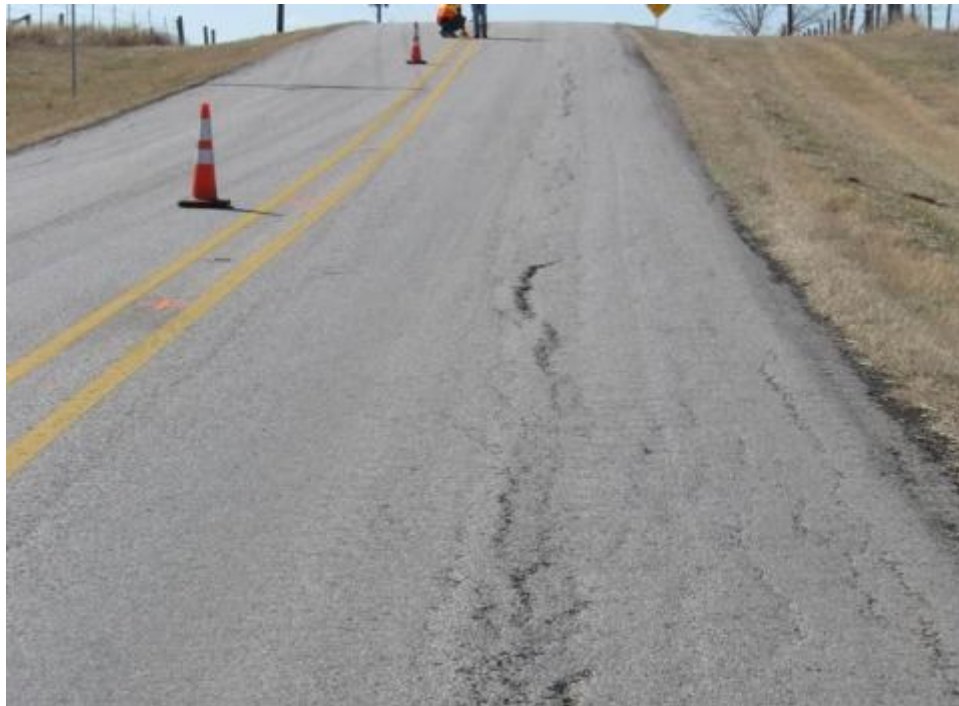
- Surface texture type: Coarse.
- Lane width: Irregular, between 10.0ft to 11.5ft.
- Shoulder: No paved shoulder.
- Horizontal curve: Straight path.
- Vertical curve: Uphill.
- Observed pavement distresses: Several unsealed cracks.
- Additional comments: This section was resurfaced between the reference data collection and the automated measurements and therefore it was discarded for the comparison.

Figure 3.6: Section 2: FM 1466.

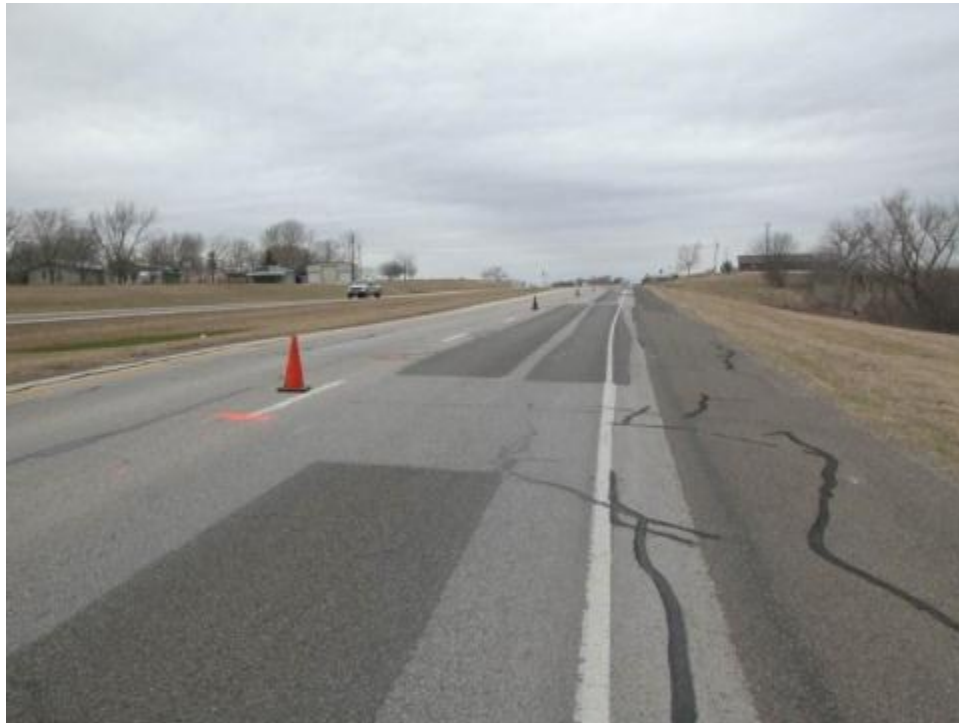
- Surface texture type: Fine original pavement surface with coarse patches.
- Lane width: Uniform, 12.0ft.
- Shoulder: Paved shoulder.
- Horizontal curve: Slight curve.
- Vertical curve: Slightly uphill.
- Observed pavement distresses: presence of patches within and between the wheel paths and sealed cracks.
- Additional comments: Possible ponding of water between patches.

Figure 3.7: Section 3: US 79-1.

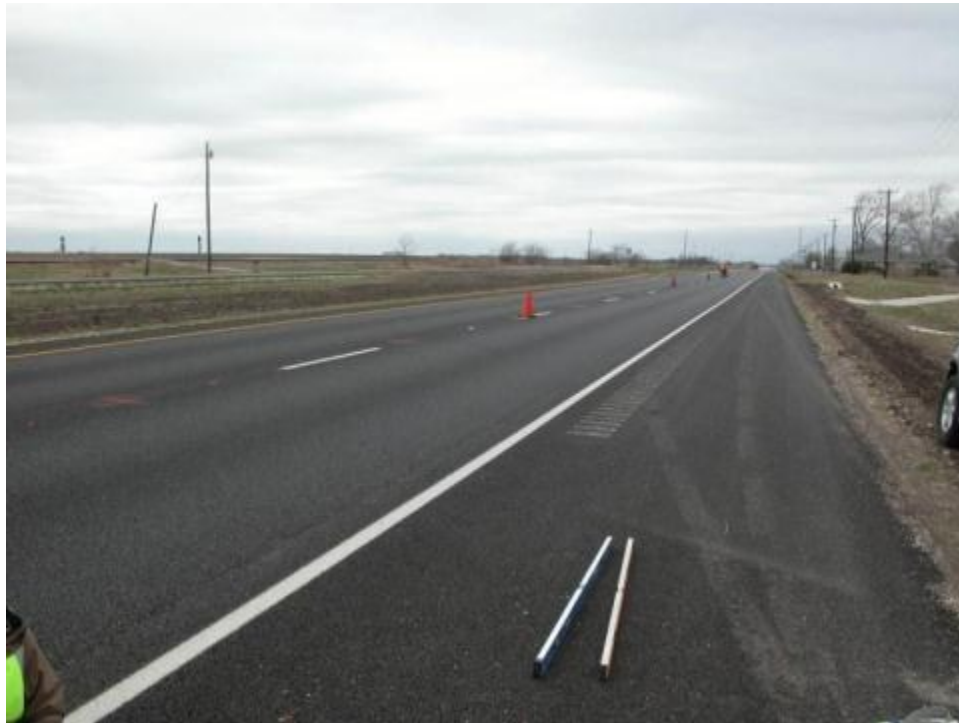
- Surface texture type: Coarse.
- Lane width: Regular, 12.0ft.
- Shoulder: Paved shoulder.
- Horizontal curve: Straight.
- Vertical curve: Flat.
- Observed pavement distresses: No distresses observed.
- Additional comments: Very open surface texture.

Figure 3.8: Section 4: US 79-2.

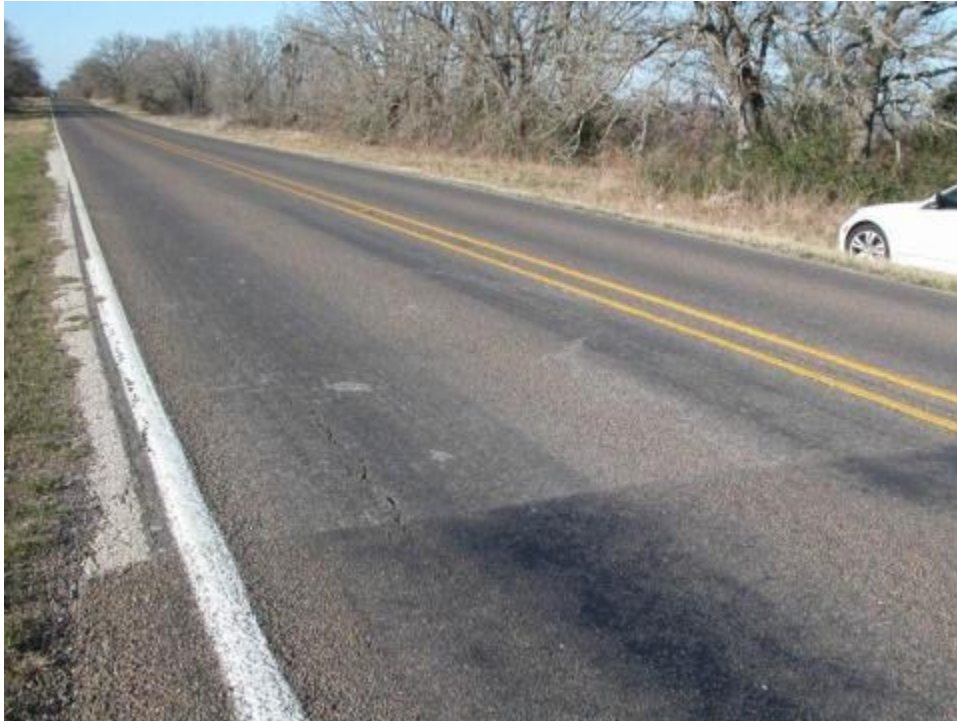
- Surface texture type: Coarse.
- Lane width: Regular, 10.0ft.
- Shoulder: No paved shoulder.
- Horizontal curve: Straight.
- Vertical curve: Flat.
- Observed pavement distresses: Some unsealed cracks and flushing.
- Additional comments:

Figure 3.9: Section 5: FM 696-1.

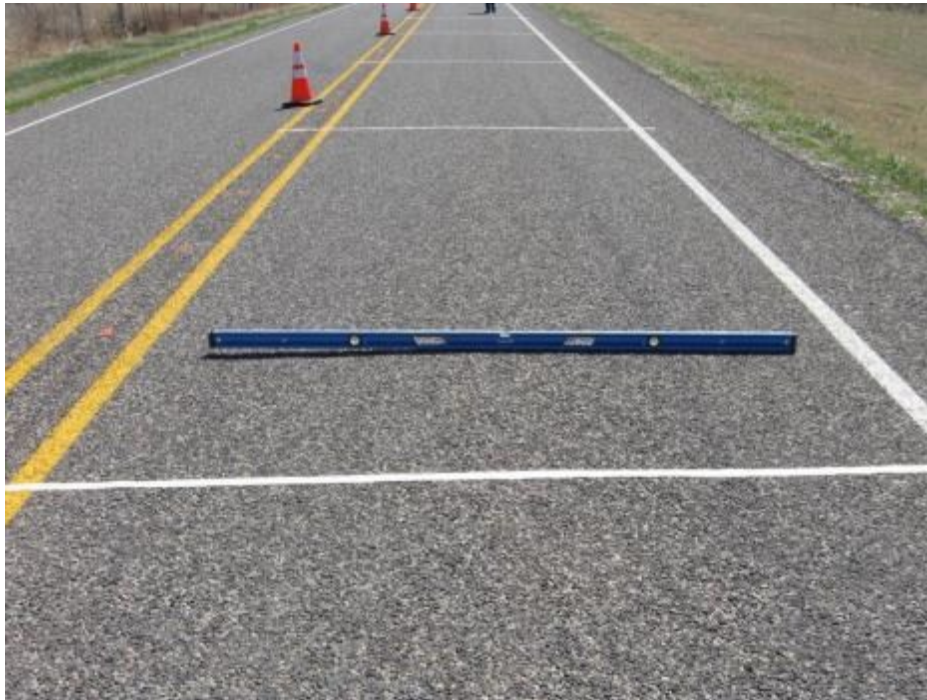
- Surface texture type: Coarse.
- Lane width: Regular, 10.0ft.
- Shoulder: paved shoulder.
- Horizontal curve: Straight.
- Vertical curve: Flat.
- Observed pavement distresses: No distresses observed.
- Additional comments:

Figure 3.10: Section 6: FM 619-1.

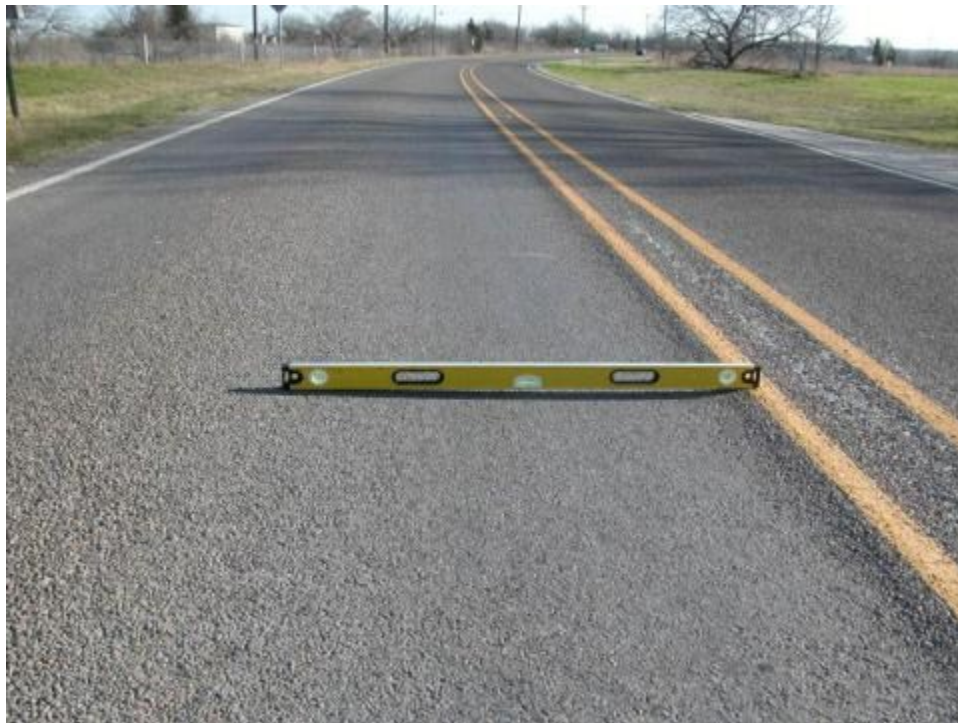
- Surface texture type: Coarse.
- Lane width: Irregular, between 10.0ft to 11.0ft.
- Shoulder: No paved shoulder.
- Horizontal curve: Left horizontal curve.
- Vertical curve: Flat.
- Observed pavement distresses: Minor bleeding along wheel-paths.
- Additional comments:

Figure 3.11: Section 7: FM 696-2.

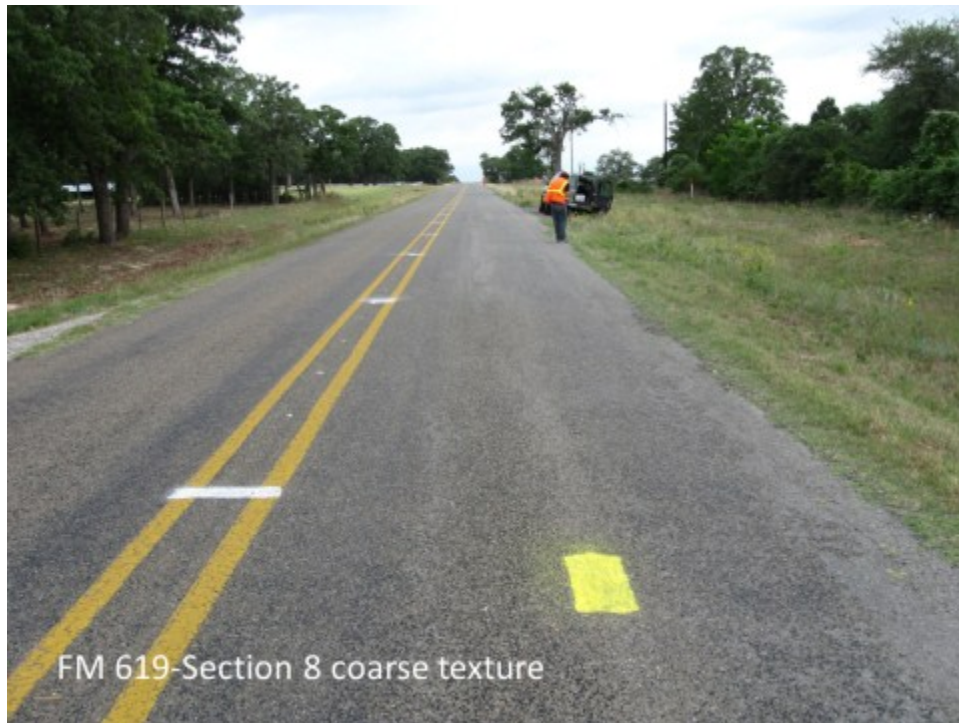
- Surface texture type: Coarse.
- Lane width: Irregular, between 9.5ft to 11.5ft.
- Shoulder: No paved shoulder.
- Horizontal curve: Straight.
- Vertical curve: Flat.
- Observed pavement distresses: Presence of raveling.
- Additional comments:

Figure 3.12: Section 8: FM 619 -2.

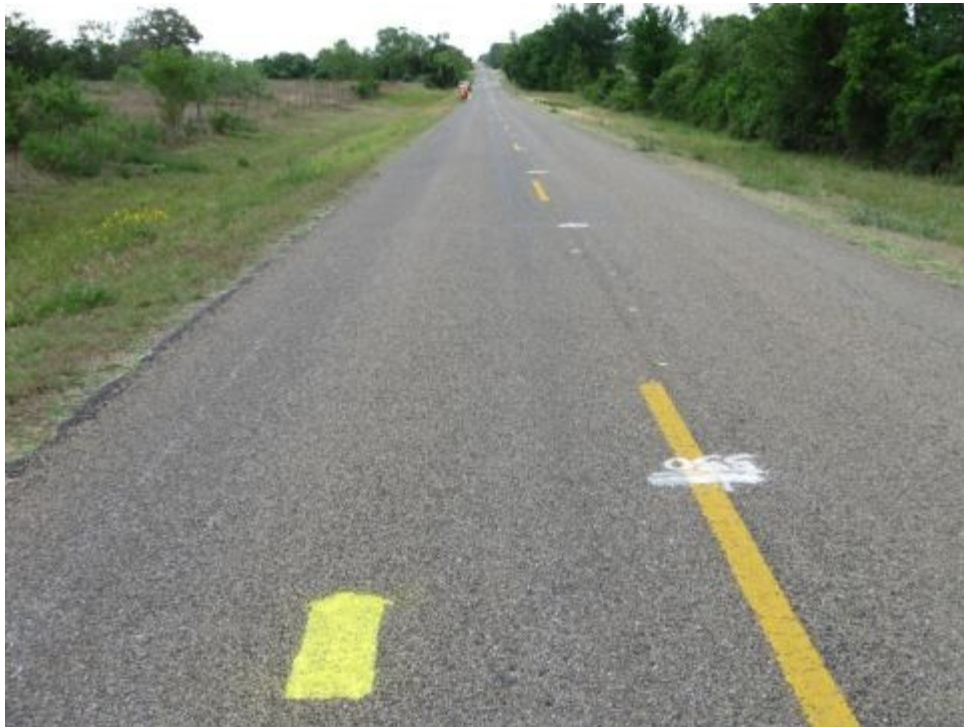
- Surface texture type: Coarse.
- Lane width: Irregular, between 9.5ft to 10.0ft.
- Shoulder: No paved shoulder.
- Horizontal curve: Straight.
- Vertical curve: Slightly uphill.
- Observed pavement distresses: Minor unsealed cracking.
- Additional comments:

Figure 3.13: Section 9: FM 619-3.

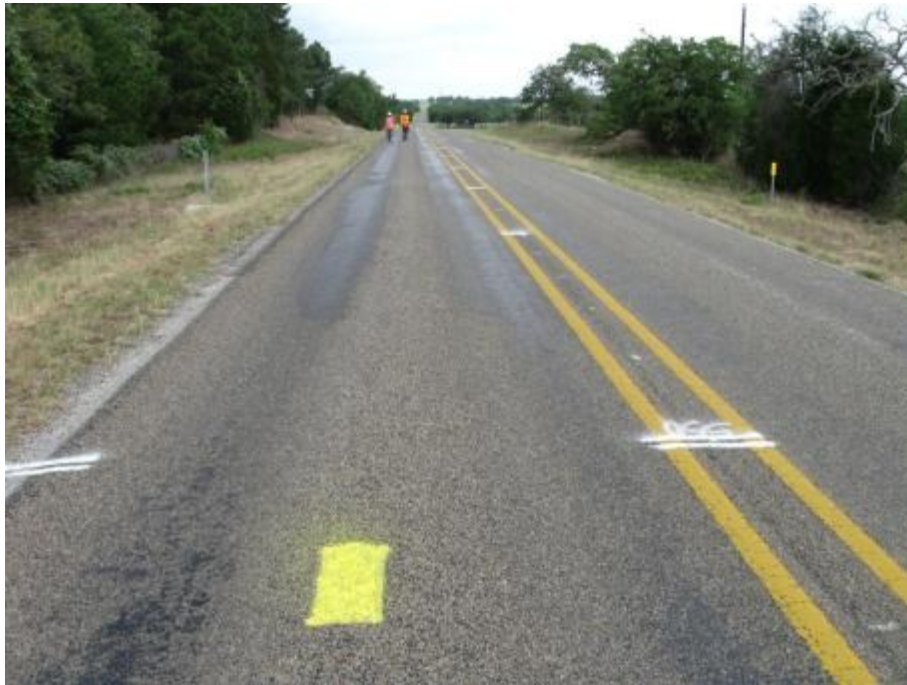
- Surface texture type: Coarse.
- Lane width: Irregular, between 10.0ft to 10.5ft.
- Shoulder: No paved shoulder.
- Horizontal curve: Straight.
- Vertical curve: Slightly uphill.
- Observed pavement distresses: Presence flushing.
- Additional comments:

Figure 3.14: Section 10: FM 619-4.

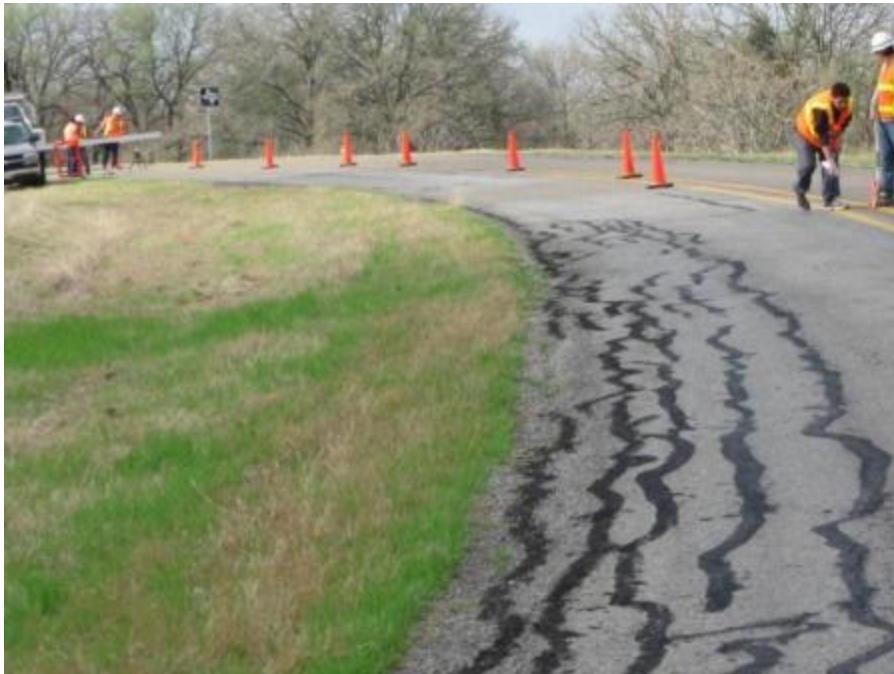
- Surface texture type: Coarse.
- Lane width: Irregular, between 9.0ft to 10.5ft.
- Shoulder: No paved shoulder.
- Horizontal curve: Sharp right curve.
- Vertical curve: Slightly uphill.
- Observed pavement distresses: Presence of patches and several sealed and unsealed cracks, edge drop offs, variable surface coloration
- Additional comments:

Figure 3.15: Section 11: FM 619-5.

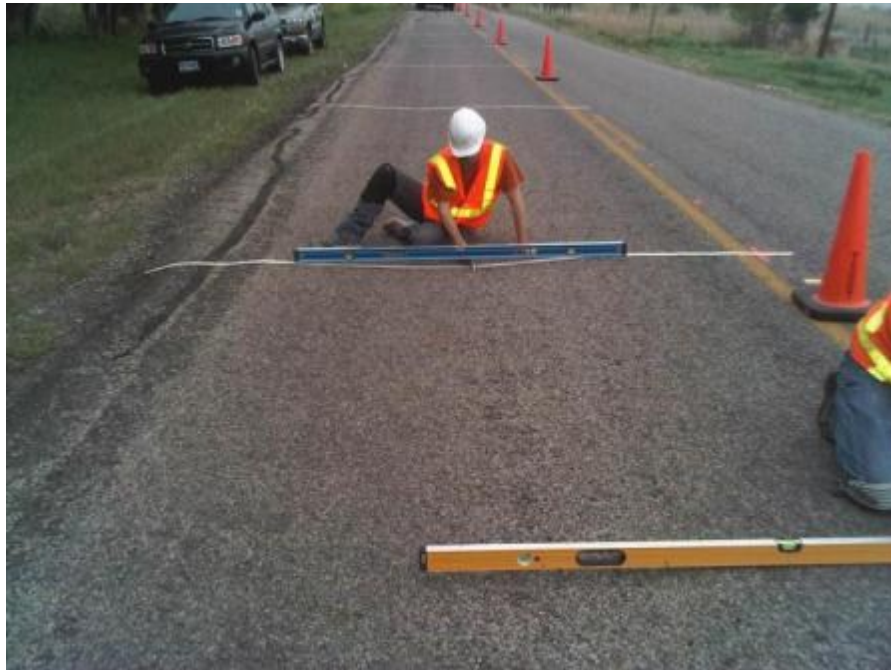
- Surface texture type: Coarse.
- Lane width: Irregular, between 11.0ft to 12.0ft.
- Shoulder: No paved shoulder.
- Horizontal curve: Slight right curve.
- Vertical curve: Flat.
- Observed pavement distresses: Edge drop-off and presence of sealed cracks.
- Additional comments: Section start point just beyond a narrow load zoned bridge.

Some stations present centered rut (as shown in picture).

Figure 3.16: Section 12: FM1063-1.

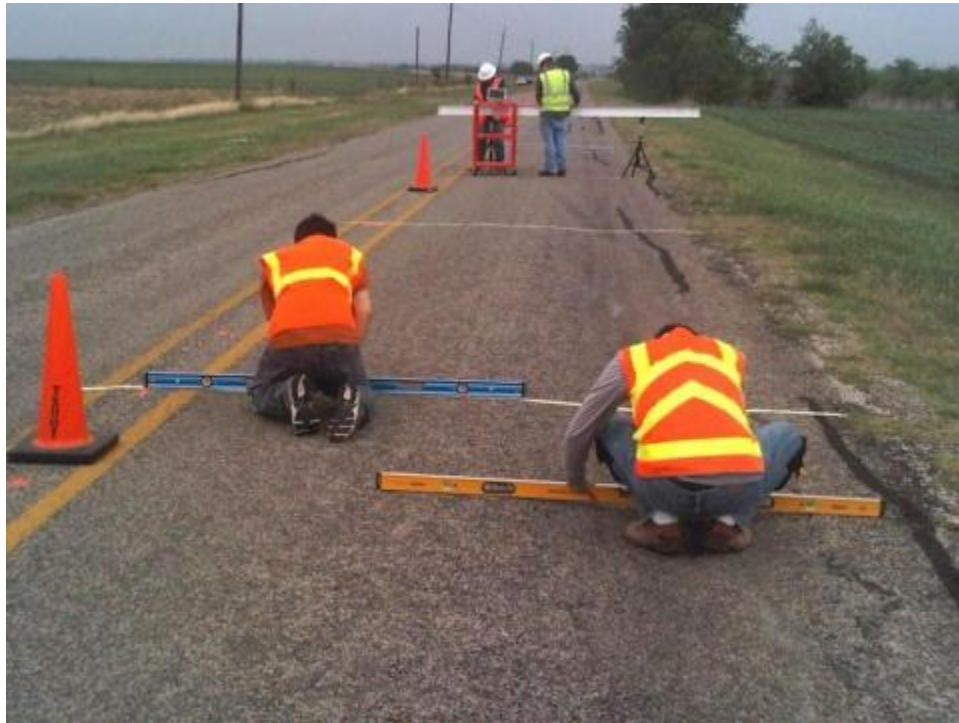
- Surface texture type: Coarse.
- Lane width: Irregular, between 10.5ft to 11.0ft.
- Shoulder: No paved shoulder.
- Horizontal curve: Straight.
- Vertical curve: Flat.
- Observed pavement distresses: Some sealed cracks.
- Additional comments:

Figure 3.17: Section 13: FM 1063-2.

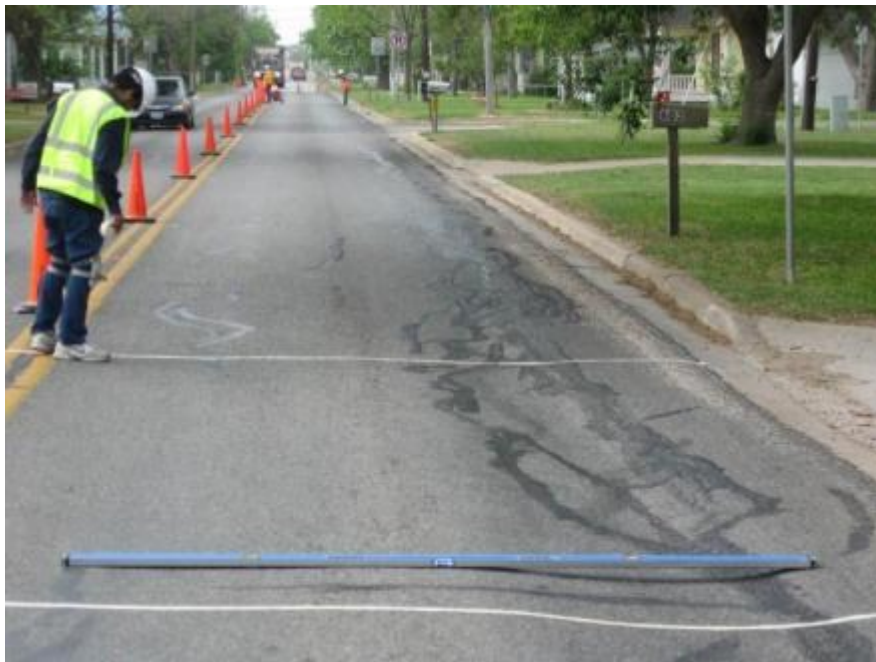
- Surface texture type: Fine between Station 000 and Station 260 and coarse between Station 260 and Station 550.
- Lane width: Regular, 12.0ft.
- Shoulder: No shoulder (curb and gutter).
- Horizontal curve: Straight.
- Vertical curve: Flat.
- Observed pavement distresses: Several sealed cracks (between 260ft to 550ft).
- Additional comments: This section is located in an urban area, with a posted speed limit of 30mph. Repeatability and reproducibility tests for the manual measurement of MRD were performed in this section.

Figure 3.18: Section 14: FM 1660-2.

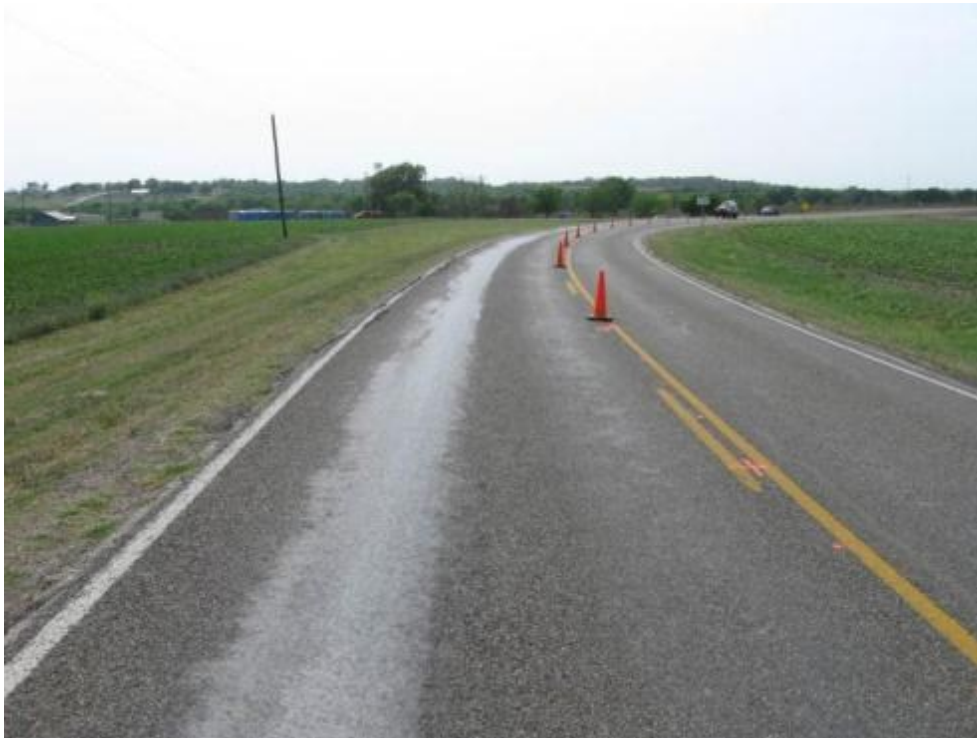
- Surface texture type: Coarse.
- Lane width: Irregular, between 10.5ft to 11.0ft.
- Shoulder: No paved shoulder.
- Horizontal curve: Sharp left curve.
- Vertical curve: Slightly uphill.
- Observed pavement distresses: Severe Bleeding OWP, variable flushing IWP. along wheel-paths and some sealed cracks.
- Additional comments:

Figure 3.19: Section 15: FM 112-1.

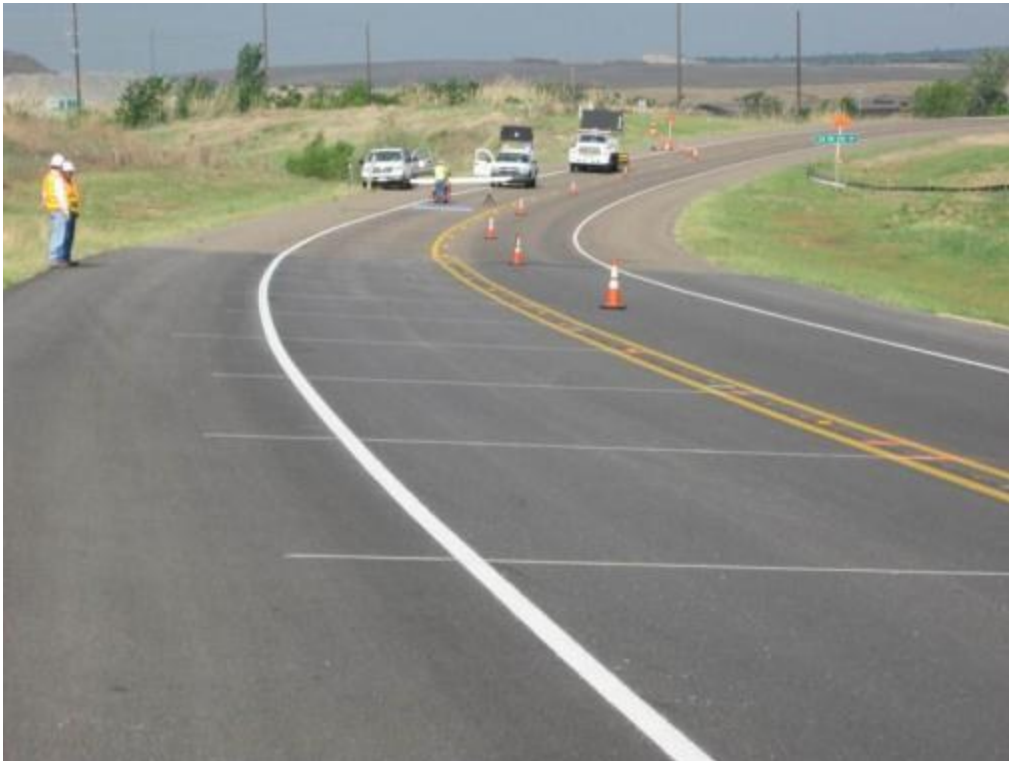
- Surface texture type: Coarse between Station 000 and Station 300 and fine between Station 300 and Station 550.
- Lane width: Regular, 11.0ft.
- Shoulder: Paved shoulder.
- Horizontal curve: Moderate left curve.
- Vertical curve: Slightly uphill.
- Observed pavement distresses: No major distresses observed.
- Additional comments: Variation in surface coloration and texture.

Figure 3.20: Section 16: FM 696-3.

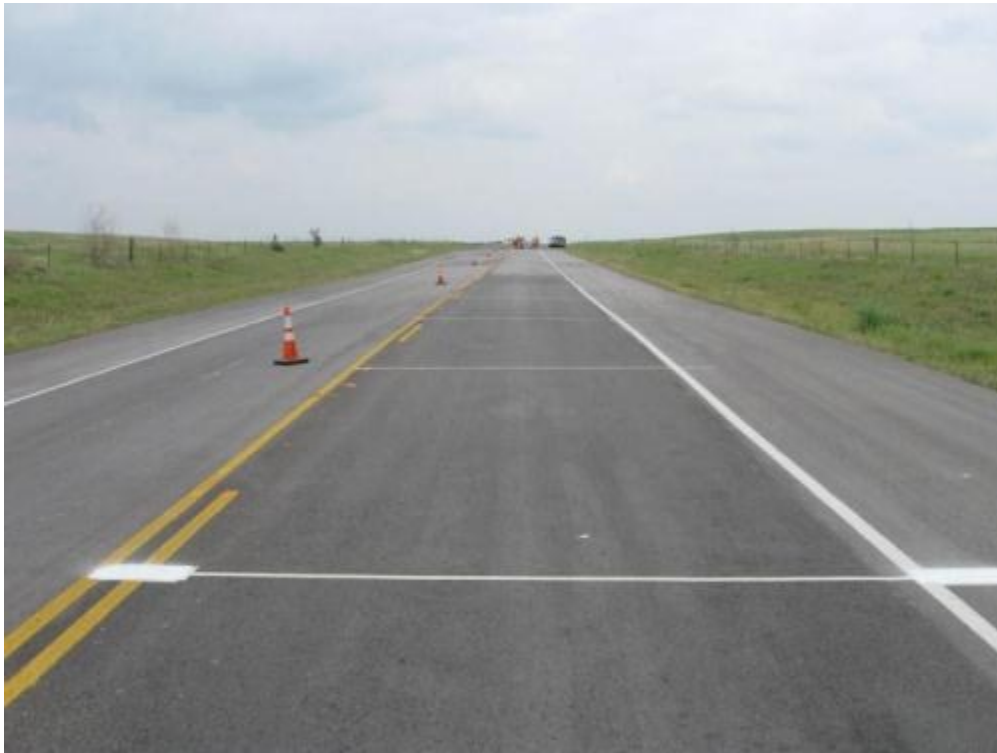
- Surface texture type: Coarse between Station 165 and Station 390 and fine everywhere else.
- Lane width: Regular, 11.0ft.
- Shoulder: Paved shoulder.
- Horizontal curve: Straight.
- Vertical curve: Flat.
- Observed pavement distresses: Presence of patches.
- Additional comments:

Figure 3.21: Section 17: FM 696-4.

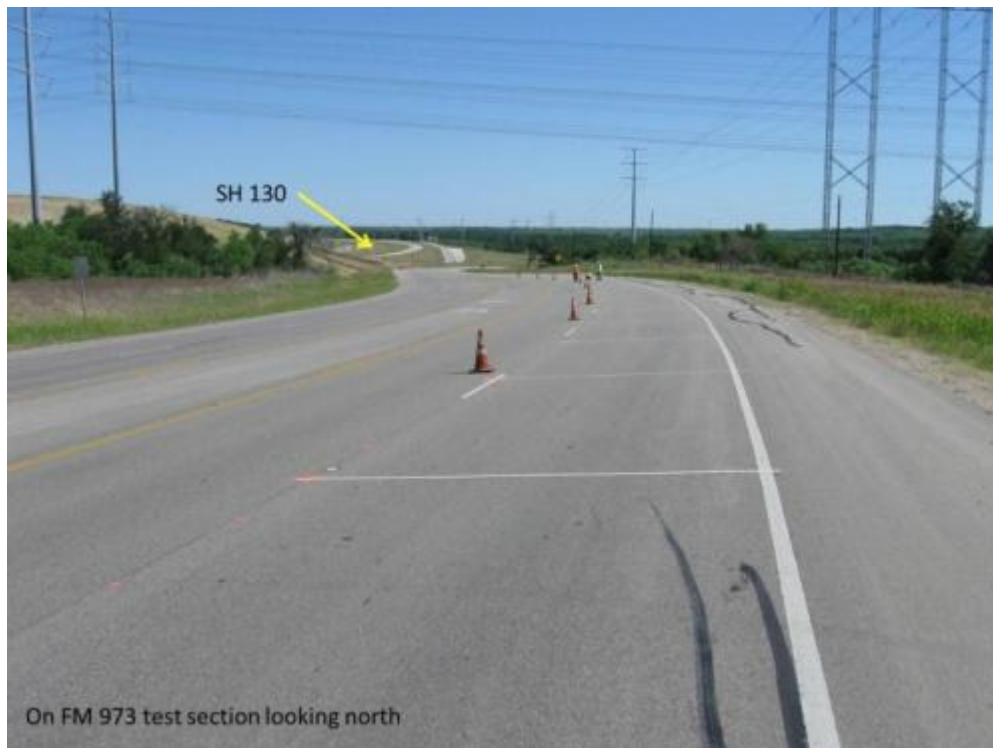
Figure 3.22: Section 18: FM 973.

- Surface texture type: Fine.
- Lane width: Regular, 12.0ft.
- Shoulder: Paved shoulder.
- Horizontal curve: Sharp left curve.
- Vertical curve: Slightly down-hill.
- Observed pavement distresses: Few sealed cracks.
- Additional comments: Presence of construction joint.

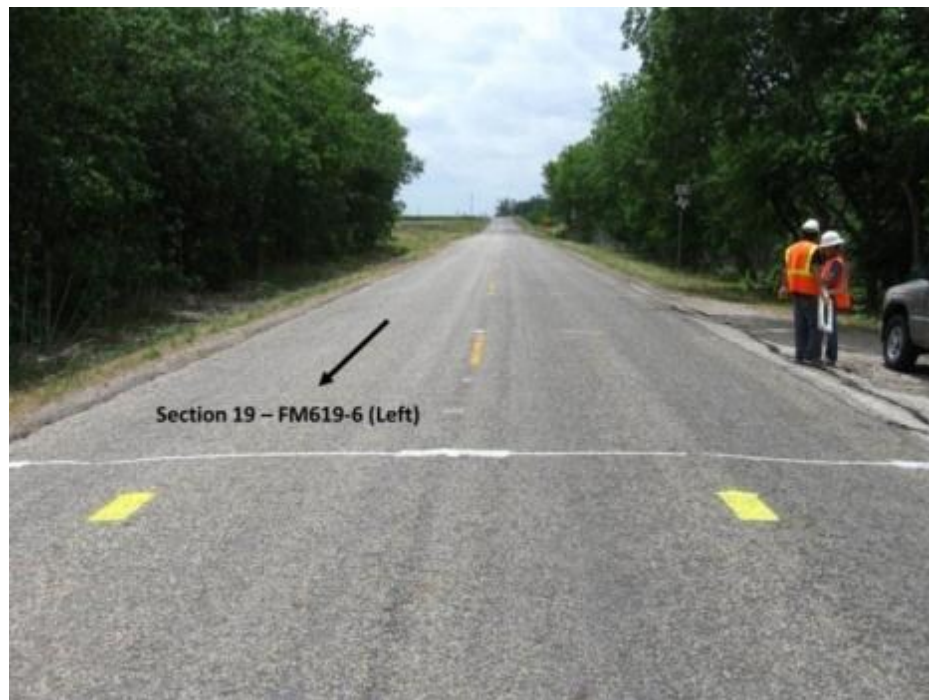
Figure 3.23: Section 19: FM 619-6.

- Surface texture type: Coarse.
- Lane width: Irregular, between 11.0ft to 12.0ft.
- Shoulder: No paved shoulder.
- Horizontal curve: Straight.
- Vertical curve: Flat.
- Observed pavement distresses: Several wide unsealed cracks and few sealed cracks.
- Additional comments: Adjacent to Section 20 (as shown in Figure 3.23).

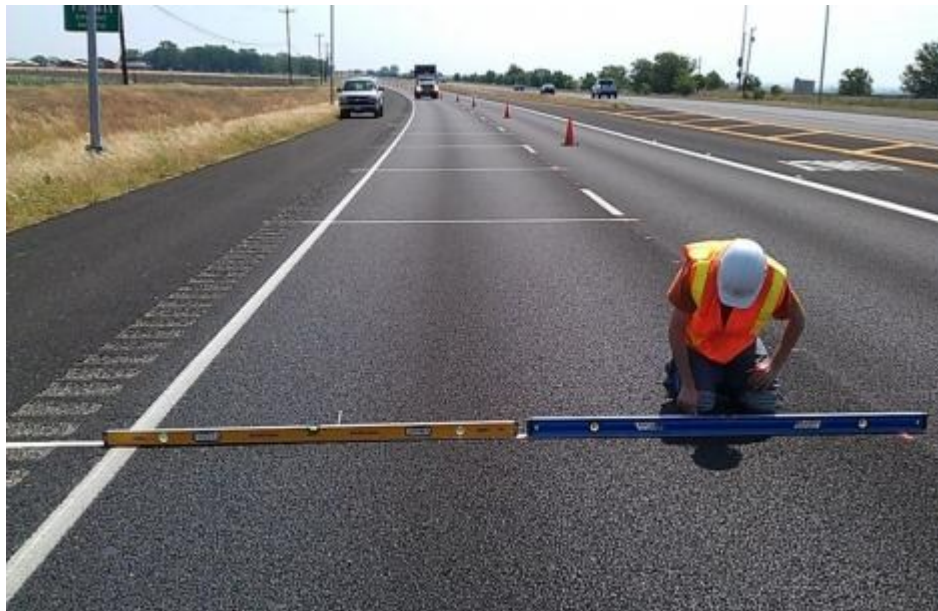
Figure 3.25: Section 21: US 79-3.

- Surface texture type: Coarse.
- Lane width: Regular, 11.0ft.
- Shoulder: Paved shoulder.
- Horizontal curve: Slight right curve.
- Vertical curve: Flat.
- Observed pavement distresses: No distresses observed.
- Additional comments: Open surface texture. Located immediately preceding Section 22.

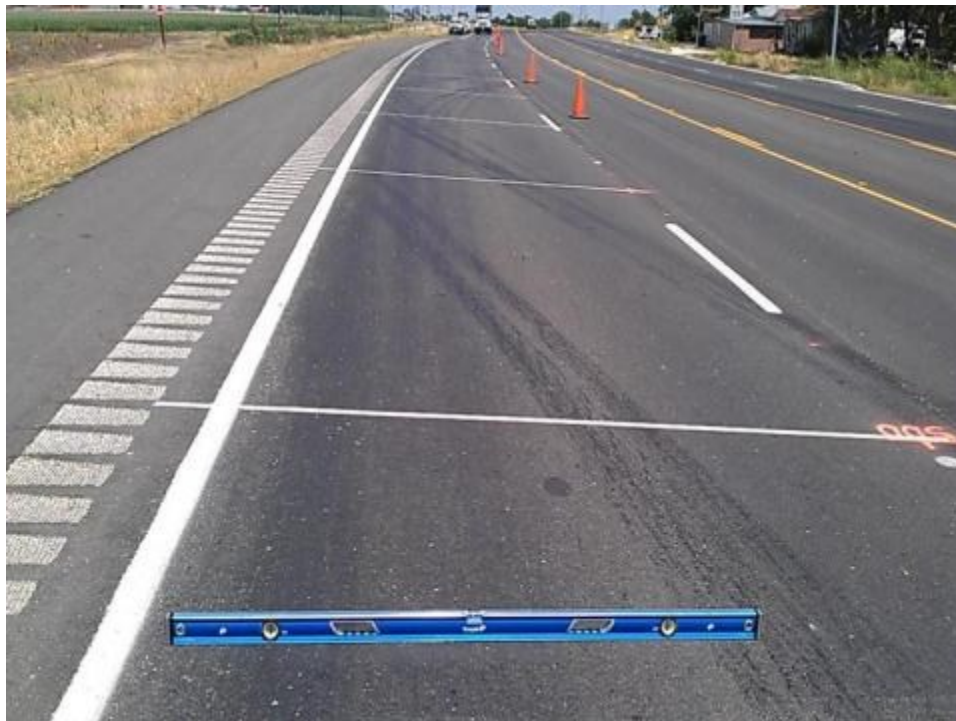
Figure 3.26: Section 22: US 79-4.

- Surface texture type: Fine.
- Lane width: Regular, 11.0ft.
- Shoulder: Paved shoulder.
- Horizontal curve: Slight left curve.
- Vertical curve: Flat.
- Observed pavement distresses: No distresses observed.
- Additional comments: Immediately follows Section 21.

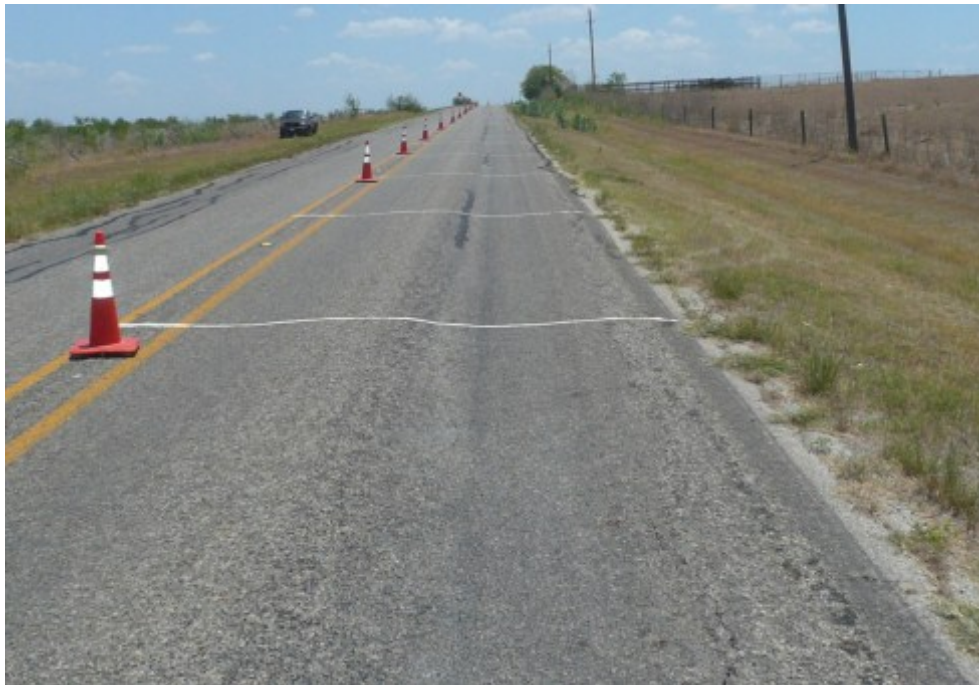
Figure 3.27: Section 23: FM 1063-3.

- Surface texture type: Coarse.
- Lane width: Irregular, between 10.0ft to 11.0ft.
- Shoulder: No paved shoulder.
- Horizontal curve: Straight.
- Vertical curve: Uphill.
- Observed pavement distresses: Presence of both sealed and unsealed cracks.
- Additional comments: Adjacent to Section 24 (as shown in Figure 3.27).

Repeatability and reproducibility tests for the manual measurement of MRD were performed in this section.

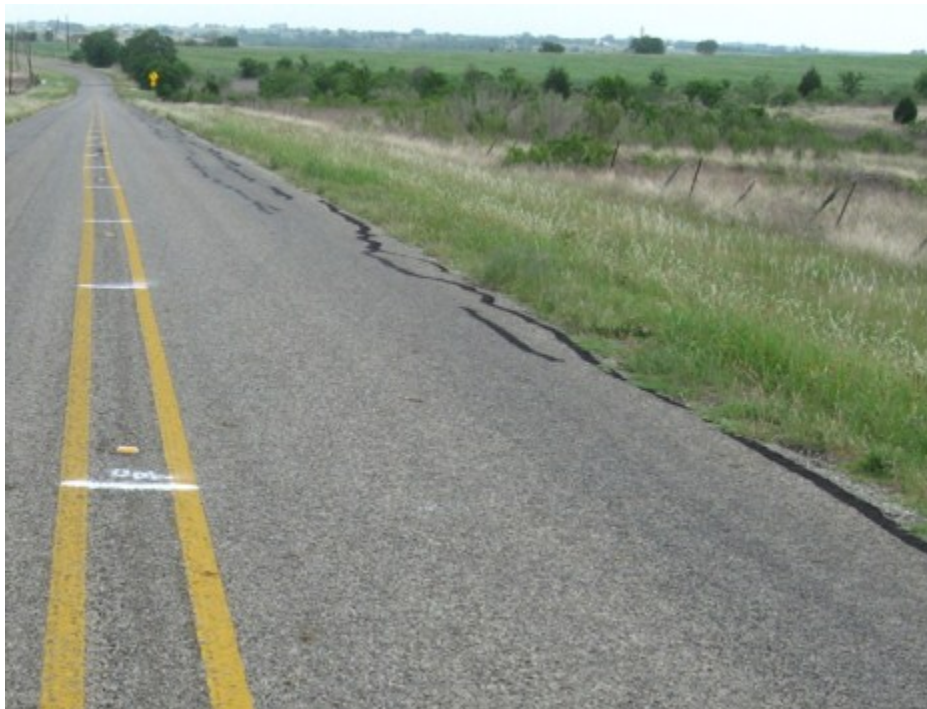
Figure 3.28: Section 24: FM 1063-4.

- Surface texture type: Coarse.
- Lane width: Irregular, between 9.5ft to 11.0ft.
- Shoulder: No paved shoulder.
- Horizontal curve: Straight.
- Vertical curve: Downhill.
- Observed pavement distresses: Presence of both sealed and unsealed cracks.
- Additional comments: Adjacent to Section 23(as shown in Figure 3.28).

Repeatability and reproducibility tests for the manual measurement of MRD and transverse profiles were performed in this section.
